Pollution from wind turbine blades

5 th. Edition - English

Asbjørn Solberg, Bård-Einar Rimereit and
Jan Erik Weinbach

“THE TURBINE GROUP” JULY 2021

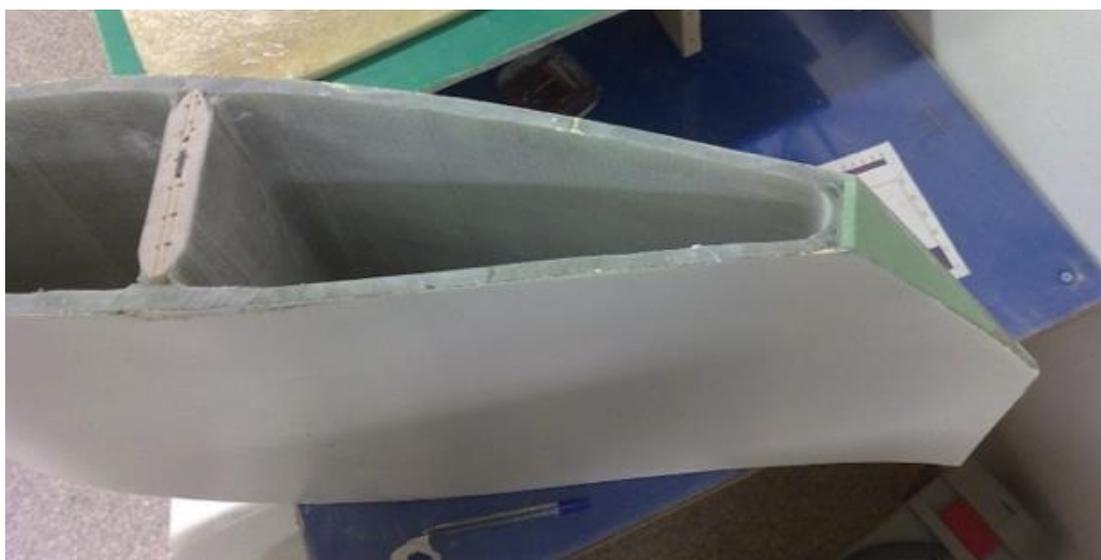
Figure 5 Photo: A small blade profile - to get an impression of proportions. Own photo, from testing

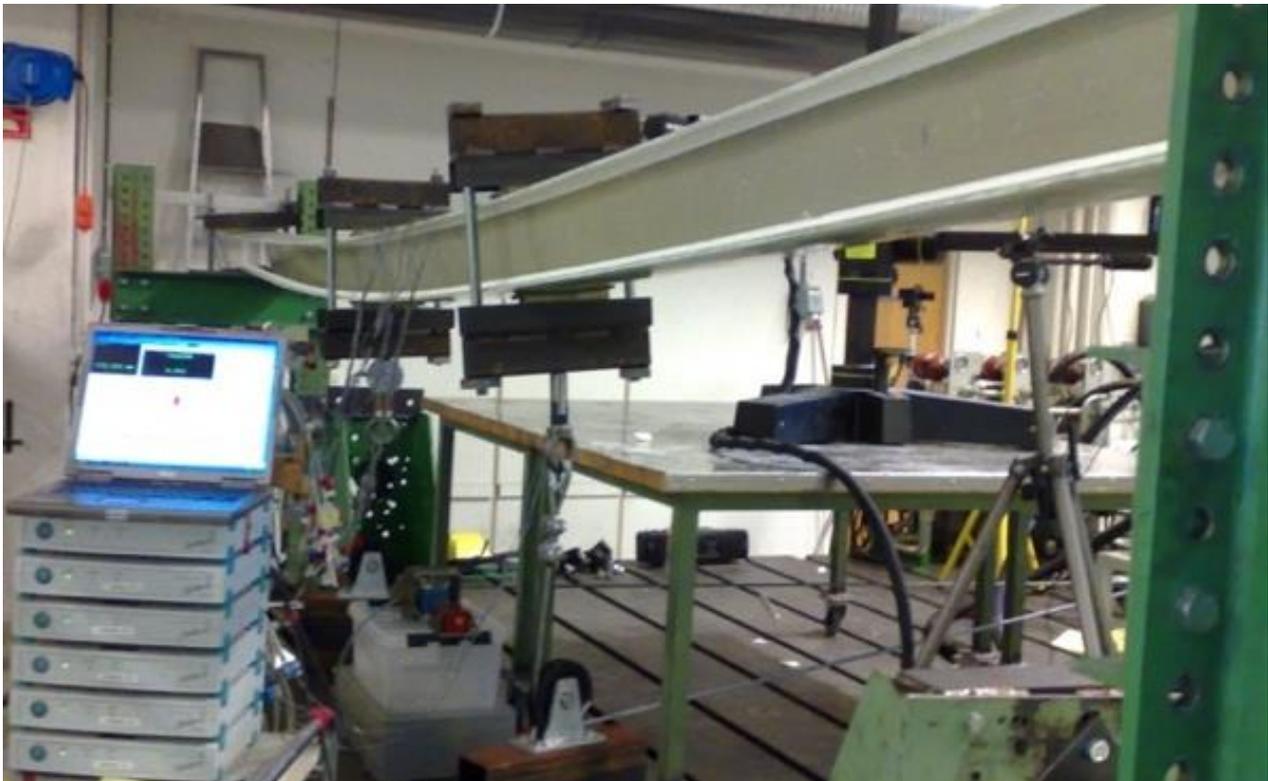
Figure 7 Photo: Bending test of a section on a wing profile. Own photo, from testing
